**Flood Control Project Maintenance
Levee Inspections****LMA District Cover Sheet
Spring 2014 Levee Inspection Results****Reclamation District No. 0010 Honcut**

Spring 2014 Levee Inspection Results

Reclamation District No. 0010 Honcut

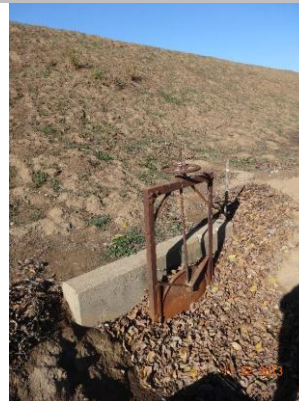
Photo 1 of 1 : UCIP_5503.jpg

View of screw gate located on landward side.

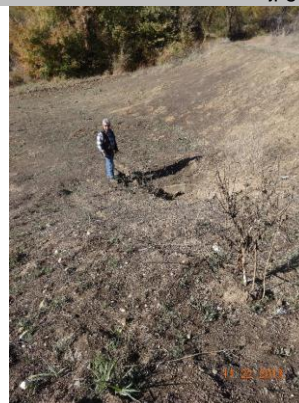
Photo 1 of 1 : UCIP_4274.jpg

LM Start	7.27	Rating **	M	Issue No.	18
LM End	7.27	Issue Type +	En	Location *	WS
Category	Supplemental			GPS Latitude/Longitude	
				Start	End
Item	DWR UCIP Field Study			39.264639 °	39.264639 °
				-121.613745 °	-121.613745 °
DWR ID	DWR_RD0010_02_s_2014_18				
Action/Comments					
Inspector Comments: FS_ID:24830					
EP_NO: N/A					
Repair Type:					
Crossing Status:					
UCIP Comments: Both openings of crossing are blocked by sediment-screw gate is damage. Recommend notifying owner to repair screw gate and remove sediment build-up blocking openings. This crossing is referenced in the USACE Periodic Inspection as item USACE_CESPK_HON2_2013_p_0295.					
FIELD_STRUCT_DESC: 24-inch CM pipe through the levee, 13.0 feet below the crown. Two CM cutoff walls around pipe at both shoulders. Flap gate on the waterward end. Slide gate on the landward side. Concrete headwall, saddle and apron on the waterward end. (USACE-1953). This entry matches the Drainage or Irrigation Structure referenced in O&M manual (Station 471+21).

View of waterward slope.

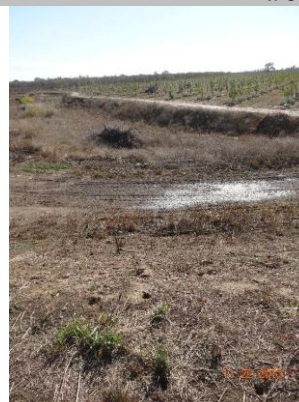
Photo 1 of 1 : UCIP_5512.jpg

LM Start	8.79	Rating **	M	Issue No.	19
LM End	8.79	Issue Type +	En	Location *	WS
Category	Supplemental			GPS Latitude/Longitude	
				Start	End
Item	DWR UCIP Field Study			39.279093 °	39.279093 °
				-121.601753 °	-121.601753 °
DWR ID	DWR_RD0010_02_s_2014_19				
Action/Comments					
Inspector Comments: FS_ID:27775					
EP_NO: N/A					
Repair Type:					
Crossing Status:					
UCIP Comments: Sediment build-up at the inlet--recommend clearing sediment. This crossing is referenced in the USACE Periodic Inspection as item USACE_CESPK_HON2_2013_p_0348.					
FIELD_STRUCT_DESC: 30-inch CM drainpipe through the levee, 23.0 feet below the crown. Two CM cutoff walls around pipe at both shoulders. Flap gate on the waterward end. Slide gate on the landward end. Concrete headwalls at both ends. Metal marker on waterward shoulder. (USACE-1953). This entry matches the Drainage or Irrigation Structure referenced in O&M manual (Station 551+96).

View of landward side.

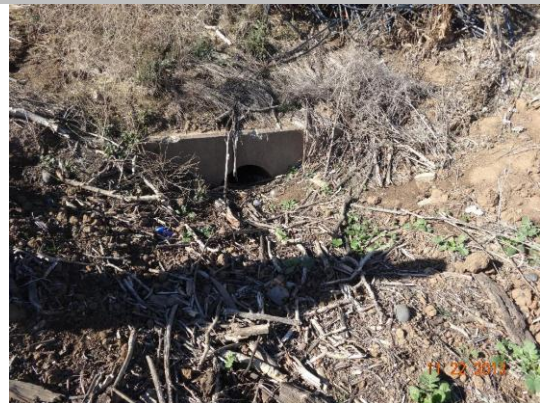
Photo 1 of 1 : UCIP_4217.jpg

LM Start	9.38	Rating **	M	Issue No.	22
LM End	9.38	Issue Type +	En	Location *	LS
Category	Supplemental			GPS Latitude/Longitude	
				Start	End
Item	DWR UCIP Field Study			39.287059 °	39.287059 °
				-121.600401 °	-121.600401 °
DWR ID	DWR_RD0010_02_s_2014_22				
Action/Comments					
Inspector Comments: FS_ID:24769					
EP_NO: N/A					
Repair Type:					
Crossing Status:					
UCIP Comments: Need to contact owner. Need to clear debris from concrete distribution box on waterward and remove debris blocking landward side.This crossing is referenced in the USACE Periodic Inspection as item USACE_CESPK_HON2_2013_p_0383.					
FIELD_STRUCT_DESC: 24-inch CM drainpipe through the levee, 12.0 feet below the crown. Two CM cutoff walls around pipe at both shoulders. Flap gate on the waterward end. Slide gate on the landward side. Concrete headwall, saddle and apron on the waterward end. Metal marker on waterward shoulder. (USACE-1953). This entry matches the Drainage or Irrigation Structure referenced in O&M manual (Station 582+72).

View of concrete headwall on landward side.

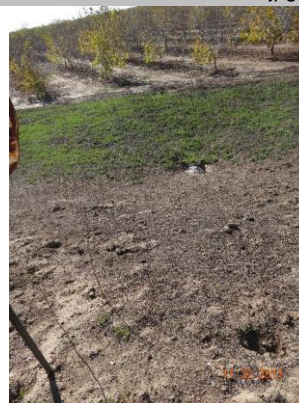
Photo 1 of 1 : UCIP_5522.jpg

LM Start	9.74	Rating **	M	Issue No.	23
LM End	9.74	Issue Type +	En	Location *	WS
Category	Supplemental			GPS Latitude/Longitude	
				Start	End
Item	DWR UCIP Field Study			39.291474 °	39.291474 °
				-121.603677 °	-121.603677 °
DWR ID	DWR_RD0010_02_s_2014_23				
Action/Comments					
Inspector Comments: FS_ID:27776					
EP_NO: N/A					
Repair Type:					
Crossing Status:					
UCIP Comments: Recommend removing debris blocking slide gate on landward side. This crossing is referenced in the USACE Periodic Inspection as item USACE_CESPK_HON2_2013_p_0402.					
FIELD_STRUCT_DESC: 24-inch drainpipe through the levee, 13.0 feet below the crown. Flap gate on the waterward end. Slide gate on the landward end. Concrete headwall at landward toe.					
FS Date: 4/30/2013

View of waterward side.

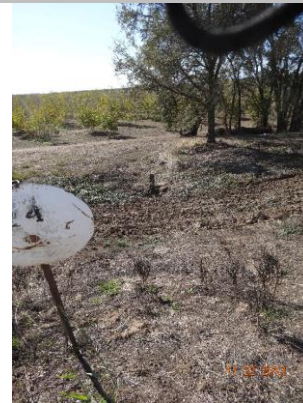
Photo 1 of 1 : UCIP_4289.jpg

LM Start	10.42	Rating **	M	Issue No.	24
LM End	10.42	Issue Type +	En	Location *	LS
Category	Supplemental			GPS Latitude/Longitude	
				Start	End
Item	DWR UCIP Field Study			39.297716 °	39.297716 °
				-121.613159 °	-121.613159 °
DWR ID	DWR_RD0010_02_s_2014_24				
Action/Comments					
Inspector Comments: FS_ID:24838					
EP_NO: 1069					
Repair Type:					
Crossing Status:					
UCIP Comments: Unable to find the crossing on landward side--					
indicators found of crossing. Need to coordinate with owner to					
determine status of crossing. If crossing is no longer in use owner will					
need to contact the CVFPB to comply with Title 23. This crossing is					
referenced in the USACE Periodic Inspection as item					
USACE_CESPK_HON2_2013_p_0442.					
FIELD_STRUCT_DESC: 24-inch steel pipe through the levee, 13.0 feet					
below the crown. Two concrete cutoff walls around pipe at both					
shoulders. Flap gate and concrete headwall on waterward end. Slide

gate and concrete saddle and apron on landward end. (Permit No. 1069-					
1941) This entry matches the Drainage or Irrigation Structure					
referenced in O&M manual (Station 638+00).					
FS Date: 4/30/2013

View of waterward side.

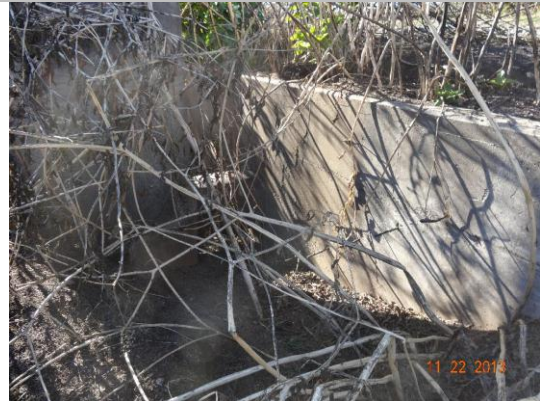
Photo 1 of 1 : UCIP_4297.jpg

LM Start	10.75	Rating **	M	Issue No.	25
LM End	10.75	Issue Type +	En	Location *	LS
Category	Supplemental			GPS Latitude/Longitude	
				Start	End
Item	DWR UCIP Field Study			39.300930 °	39.300930 °
				-121.617490 °	-121.617490 °
DWR ID	DWR_RD0010_02_s_2014_25				
Action/Comments					
Inspector Comments: FS_ID:24839					
EP_NO: N/A					
Repair Type:					
Crossing Status:					
UCIP Comments: Rip rap was used to stabilize the waterward slope during high water as a means of emergency repair--unable to determine storm event when repair was performed. Recommend obtaining records of the repair and to determine if crossing is still being used. Need to determine owner. Dense vegetation limits the inspector's visibility to identify signs of pipe failure (leaks) along the slope. Recommend removing vegetation along pipe alignment to conduct proper inspection of structure and appurtenances. This crossing is referenced in the USACE Periodic Inspection as item USACE_CESPK_HON2_2013_p_0458 and 460.

FIELD_STRUCT_DESC: 24-inch steel pipe through the levee, 5.0 feet below the crown. Slide gate in a 36-inch concrete riser on the landward shoulder. Gate valve in a pump house on the waterward slope. Concrete headwall, saddle and apron on the waterward end. (USACE-1953). This entry matches the Drainage or Irrigation Structure referenced in O&M manual (Station 655+65).					
FS Date: 4/30/2013

View of concrete wall located on landward side.

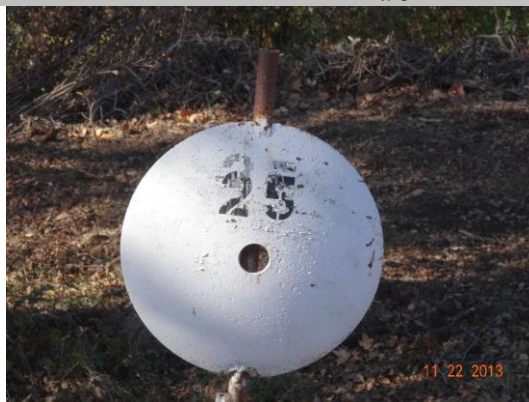
Photo 1 of 1 : UCIP_4301.jpg

LM Start	11.11	Rating **	M	Issue No.	26
LM End	11.11	Issue Type +	En	Location *	WS
Category	Supplemental			GPS Latitude/Longitude	
				Start	End
Item	DWR UCIP Field Study			39.305914 °	39.305914 °
				-121.617698 °	-121.617698 °
DWR ID	DWR_RD00010_02_s_2014_26				
Action/Comments					
Inspector Comments: FS_ID:24840					
EP_NO: N/A					
Repair Type:					
Crossing Status:					
UCIP Comments: Burrow activity--large holes found on landward side.					
Crossing on landward side is blocked. Recommend clearing headwall and crossing. Need to coordinate with owner to determine status of crossing. If crossing is no longer in use owner will need to contact the CVFPB to comply with Title 23. This crossing is referenced in the USACE Periodic Inspection as item					
USACE_CESPK_HON2_2013_p_0476.					
FIELD_STRUCT_DESC: 24-inch CM pipe through the levee, 7.5 feet below the crown. Two CM cutoff walls around pipe at both shoulders.

Flap gate on the waterward end. Concrete headwall at both toes.					
Saddle and apron on waterward side. (USACE-1953). This entry matches the Drainage or Irrigation Structure referenced in O&M manual (Station 674+73).					
FS Date: 4/30/2013

Marker visible on waterward side, crossing is referenced as No. 25.

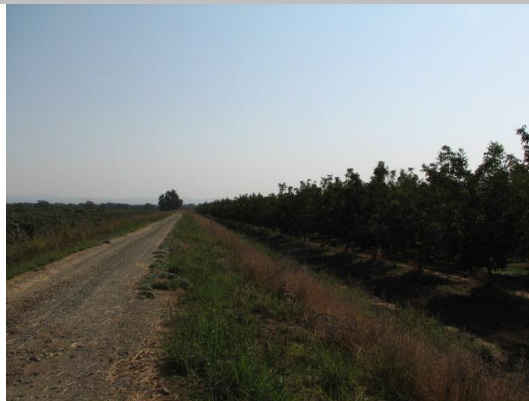
Photo 1 of 1 : mhoffman_s_20140421_478.jpg

LM Start	0.06	Rating **	M	Issue No.	4
LM End	2.66	Issue Type +	Ma	Location *	LS
Category	Earthen Levee			GPS Latitude/Longitude	
				Start	End
Item	Vegetation			39.308600 °	39.301481 °
				-121.616876 °	-121.574540 °
DWR ID	DWR_RD0010_03_f_2012_4				
Action/Comments					
Remove the wild growth other than native grasses from the levee slopes.

Levee mile 0.18, the landside slope.

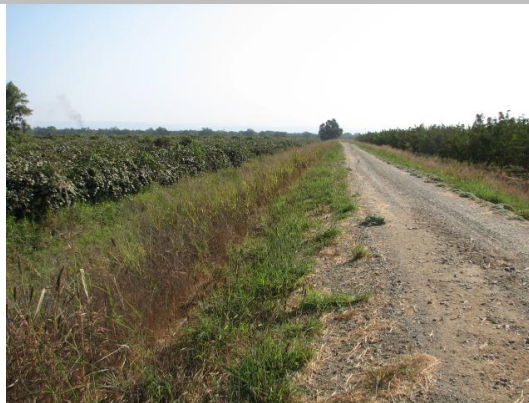
Photo 1 of 1 : mhoffman_s_20140421_479.jpg

LM Start	0.06	Rating **	M	Issue No.	6
LM End	2.66	Issue Type +	Ma	Location *	WS
Category	Earthen Levee			GPS Latitude/Longitude	
				Start	End
Item	Vegetation			39.308600 °	39.301481 °
				-121.616876 °	-121.574540 °
DWR ID	DWR_RD0010_03_f_2012_6				
Action/Comments					
Remove the wild growth other than native grasses from the levee slopes.

Levee mile 0.18, the waterside slope.

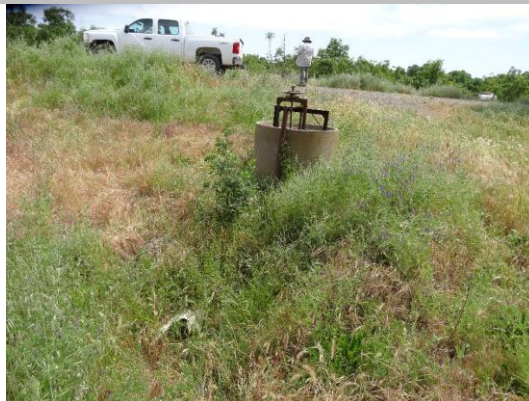
Photo 1 of 1 : UCIP_4305.jpg

LM Start	0.17	Rating **	M	Issue No.	1
LM End	0.17	Issue Type +	En	Location *	WS
Category	Supplemental			GPS Latitude/Longitude	
				Start	End
Item	DWR UCIP Field Study			39.310096 °	39.310096 °
				-121.616249 °	-121.616249 °
DWR ID	DWR_RD0010_03_s_2014_1				
Action/Comments					
Inspector Comments: FS_ID:24841					
EP_NO: N/A					
Repair Type:					
Crossing Status:					
UCIP Comments: Debris found inside crossing--recommend removing it.					
FIELD_STRUCT_DESC: 24-inch CM pipe through the levee, 6.0 feet below the crown. Slide gate in concrete standpipe on the waterward end.					
FS Date: 5/1/2013

View of concrete standpipe and plastic pipe extension visible on waterward side.

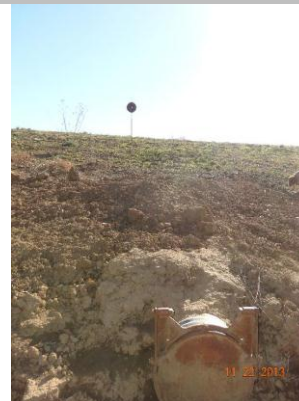
Photo 1 of 1 : UCIP_4310.jpg

View of waterward slope.

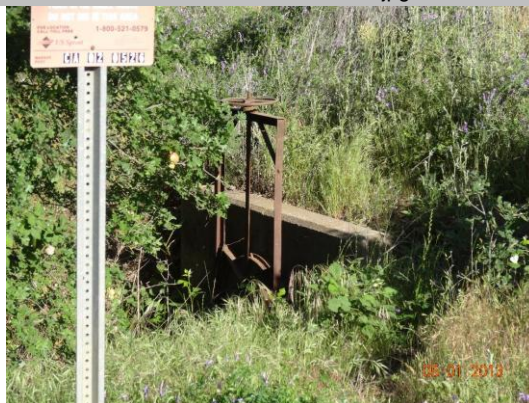
Photo 1 of 1 : UCIP_4323.jpg

LM Start	3.00	Rating **	M	Issue No.	3
LM End	3.00	Issue Type +	En	Location *	WS
Category	Supplemental		GPS Latitude/Longitude		
			Start	End	
Item	DWR UCIP Field Study		39.298561 °	39.298561 °	
			-121.569977 °	-121.569977 °

DWR ID	DWR_RD0010_03_s_2014_3
Action/Comments

Inspector Comments: FS_ID:24883
